Flood risk analysis and assessment: the case of the General State Archives of Greece

Maria Giannikou

Ourania Kanakari

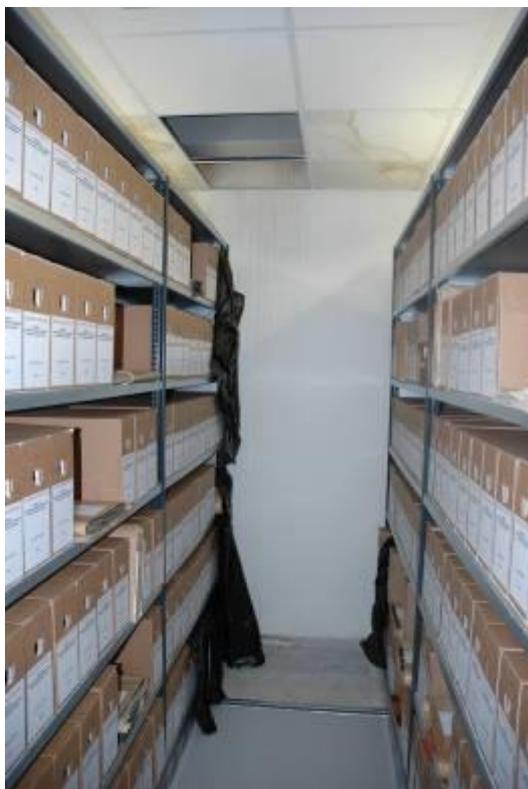
In 2008, after five years of operation, the heavy construction has gradually failed to perform as a barrier to the external environment. The building envelope was prone to wear and tear, which eventually caused small scale floods. Consequently, in 2010, an outburst of heavy rain resulted in extensive water infiltration into the inner western wall of the 1st basement where records of high importance are stored (image 2).

Image 2: Flood incident in the storage room in 2010

The routine checks for water leaks after a rainstorm, prevented significant loss. Proper actions were then set in place according to the envisaged response to emergency i.e. salvage

procedures for water damaged material, moving of intact material away from the hazardous area etc (image 3). Shortly after, a large scale insulation work was carried out to address the leak from the inside.

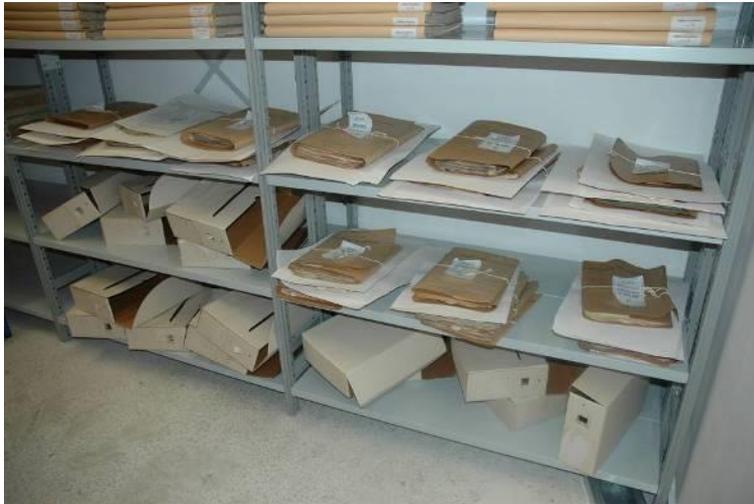
Image 3: During air drying of the water damaged material after a flood incident in 2010

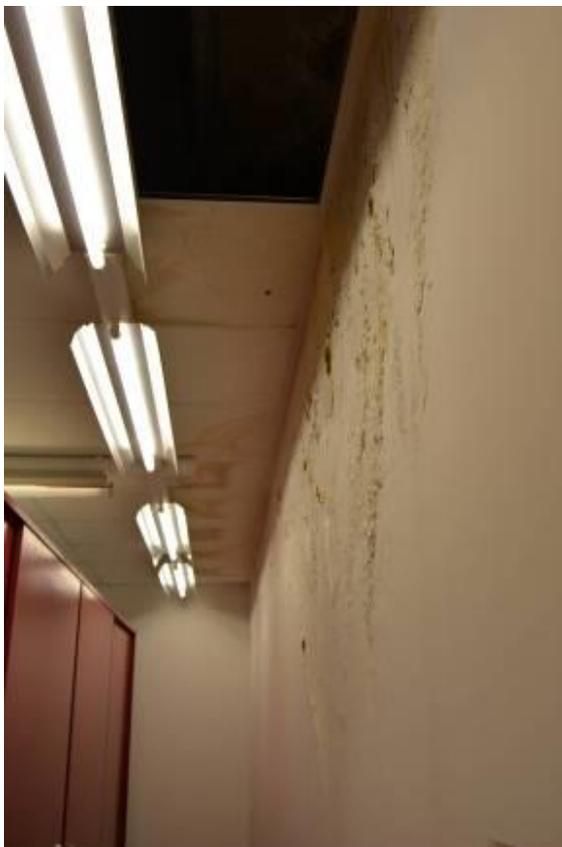
Considering that the original failure on the exterior of the building continued to be a potential risk of infiltration in adjacent areas of the inner wall, precautions were taken including the removal of the archival material nearby the wall and the protection of certain storage units with polyethylene film. In 2017, seven years after the building repair, water reappeared on the same wall but further southwards, confirming thereby the initial assumption (image 4).

Image 4: Water infiltration in the storage room in 2017

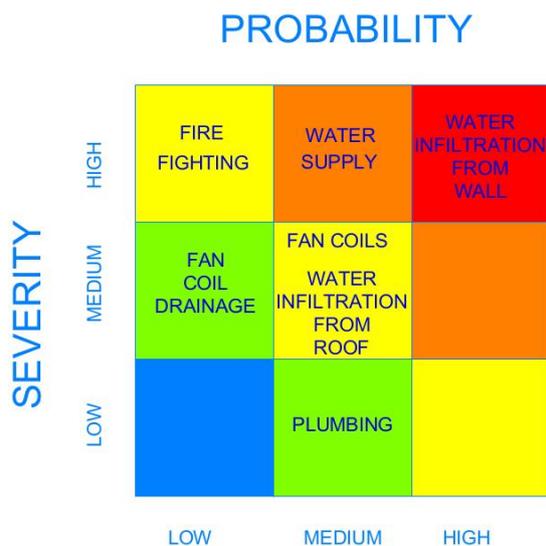
The exposure to risk depends on two parameters; probability which reflects the frequency of risk and severity on a 5 level scale (image 5). In this context, water infiltration due to failure of the building envelope is the most serious flood risk.

LOW PROBABILITY: 1 INCIDENT / 100 YEARS
 MEDIUM PROBABILITY: 1 INCIDENT / 10 YEARS
 HIGH PROBABILITY: 1 INCIDENT / 1 YEAR

Image 5: Exposure to risk matrix

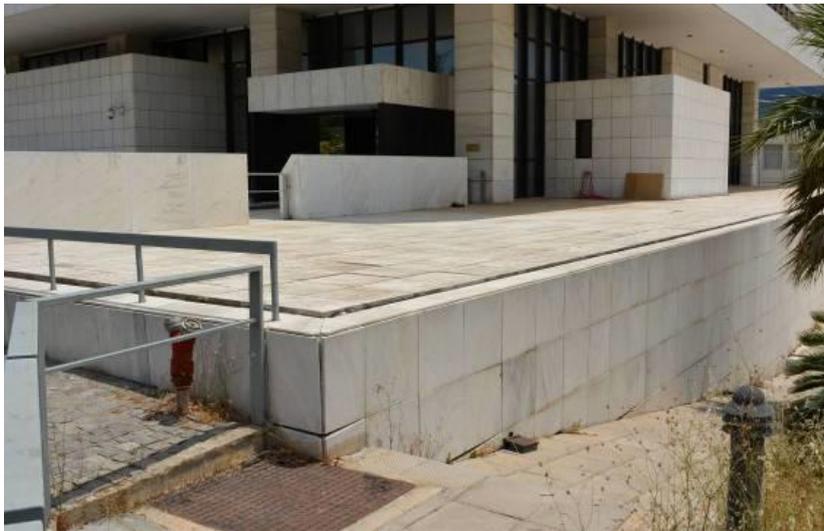
The drawings were thoroughly examined to investigate how the storage areas are exposed to the external environment, either at ground or underground level (image 6).

Image 6: Southwest view of the Central Service. In the foreground the top of the 1st basement is shown.

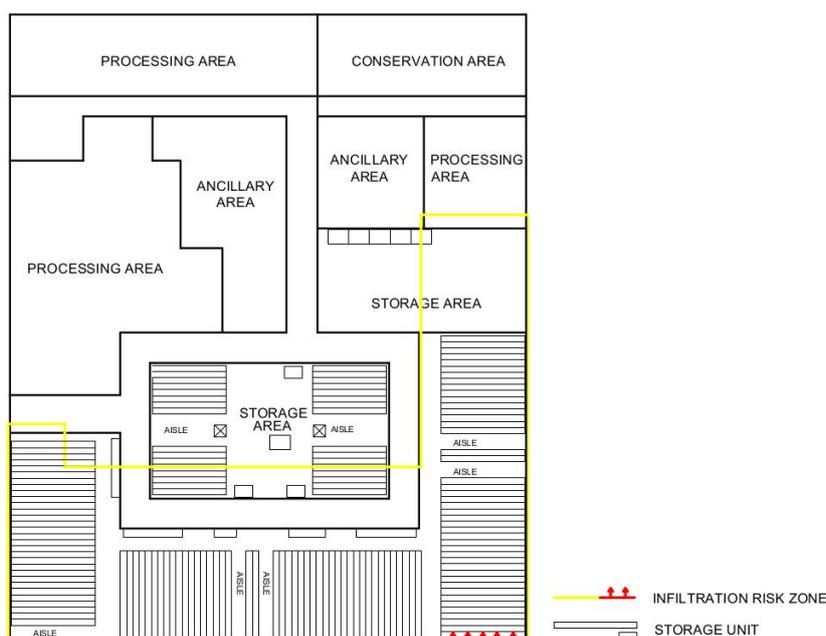
In addition, a survey provided a considerable feedback on the construction characteristics and weaknesses. Apart from the particularly pronounced problem in the western wall, a risk dynamic in other parts of the building was marked out (image 7). Small deviations recorded on the drainage system and gutters could not be accused of water infiltration into the building. Though it is questionable whether the design of these systems is capable to control 100% of the runoff generated during heavy rain-falls, in recent years.

Image 7: Mapping of the water infiltration risk zone

In the case of water infiltration in the storage rooms, the water shows up on the inside western wall but the inflow mechanism remains unknown. Water may penetrate under the failed insulation of the roof terrace at any point exposed directly to the environment, following the inclination to the side walls. During heavier storms, as the climate changes, gutters may fail to drain water properly and generate new inflow mechanisms resulting progressively in leakage from the roof.

More than half of the total area of the storage rooms is located under the terrace but the exposure to risk is considered to diminish from the western wall inwards. The appropriate solution to addressing the problem would be the radical building reconstruction of the envelope in the areas affected.

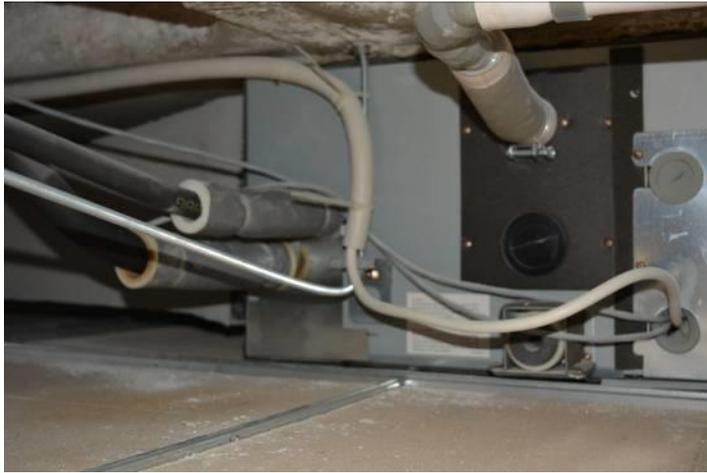
The survey was continued to confirm the location of plumbing, drainage, Heating Ventilation Air Conditioning (HVAC) and fire protection installations. The central shaft and the open ceiling suitable for archive buildings, allow easier access to mechanical systems and faster detection of ceiling leaks. A central HVAC system as well as fan coil units operate in the building and storage areas. Each unit includes a compressor that moves the refrigerant through the pipe circuit surrounded by aluminum fins. The survey resulted in a review of the situation with significant deviations compared to original reflecting drawings. The fan coil units, their associated pipe networks and drainage connections above storage shelving are a potential threat (image 8).

Image 8: Fan coil unit in the roof ceiling

The risk from the fan coils (HVAC) units is assessed of secondary importance. In case of leakage it is difficult to predict the water flow pattern through the ceiling tiles to the storage units. In theory technical characteristics such as absorption and slight inclinations of the tiles may mask water leaks until they become significant and result in a delayed and not uniform flow of water.

In addition, the mobile shelving in contrast to a static one increases the range of possible affected units. The simplest scenario of a one-off leakage of two liters of water, for example, as it was the case in the past, wetting the ceiling over one square meter area, could roughly affect two out of six units that can be found under a unit, with a small amount of water. As long as this risk has been assessed as medium and considering the number of units, the reorganization of the collections on the shelves cannot be a first-line measure.

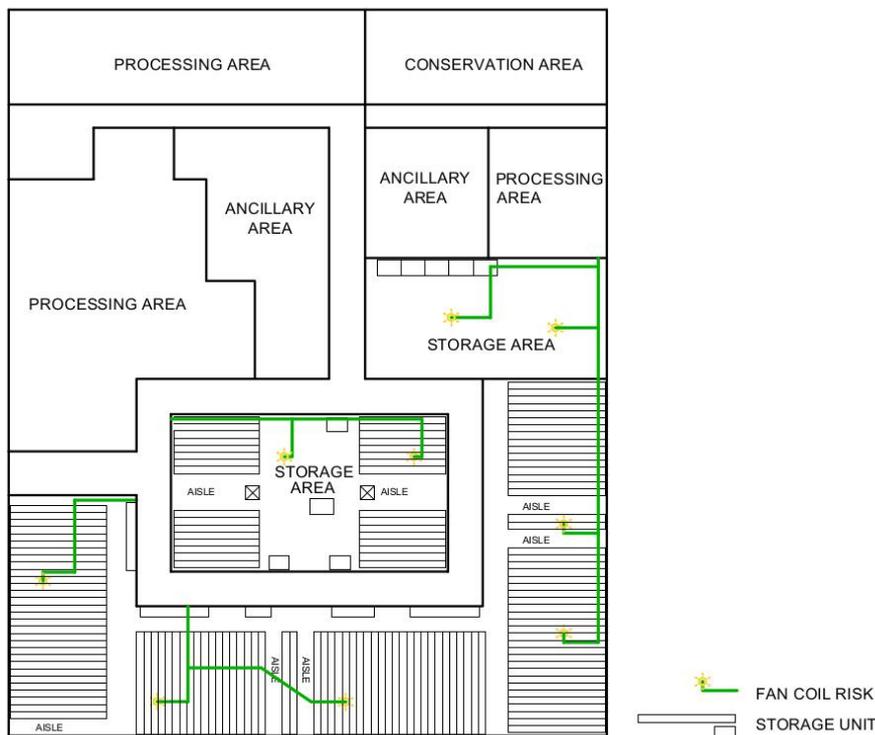
Since a regular maintenance cannot be performed an advice was sought to assess the severity of this threat. The accumulation of dust and dirt in the condensation water containers may hinder drainage and result in leakage, thus a medium probability was assigned to this risk (image 9).

Image 9: Mapping of fan coils in the storage room ceiling

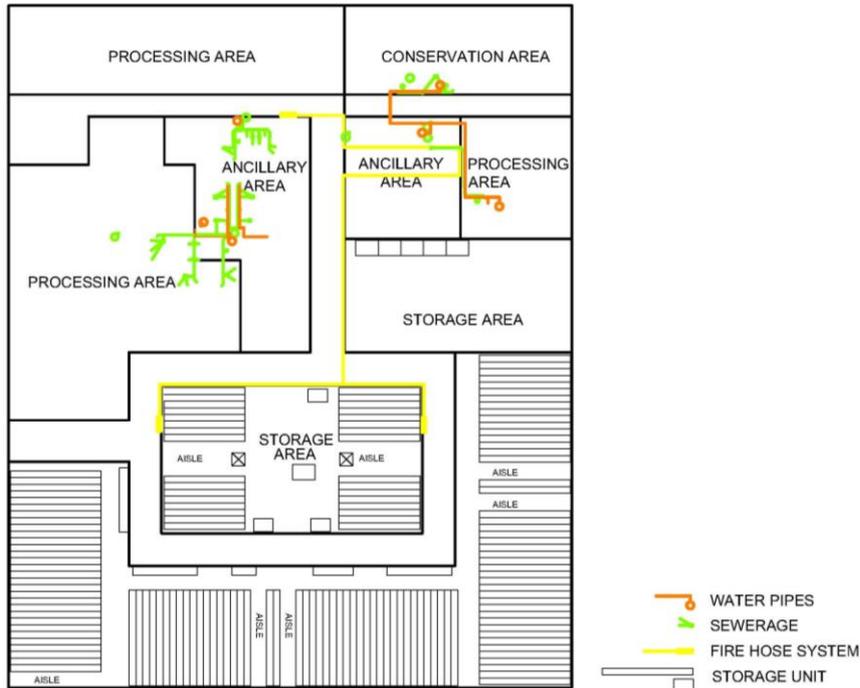
Where exposure is expected further analysis requires a scenario based approach. The fact that plumbing equipment and water supply systems, water closets, kitchens and conservation laboratory are located in a safe distance from the storage rooms was reasonable for a purpose built construction (image 10).

Image 10: Mapping of risks outside storage rooms

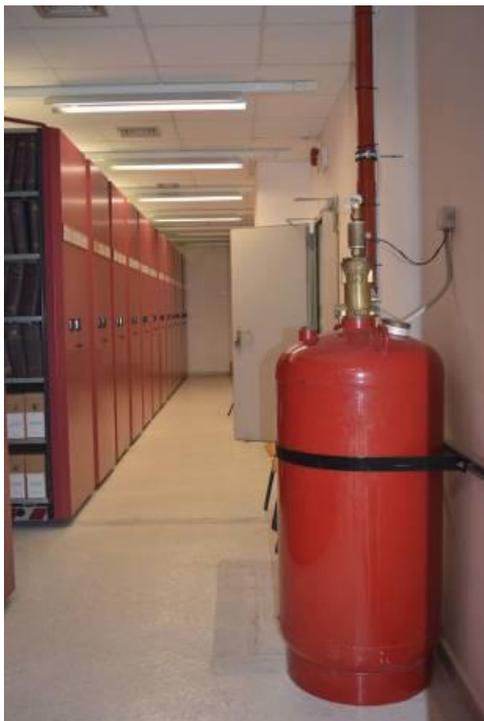
For the same reason, fire extinguishing system running inside repositories doesn't use water but the inert gas FM200 (image 11). The fire-hoses' pipe network carrying water is installed outside. Existing Condition Survey showed no changes from the original drawings leaving a serious risk and action requirement as well, behind.

Image 11: Fire extinguishing system in storage room

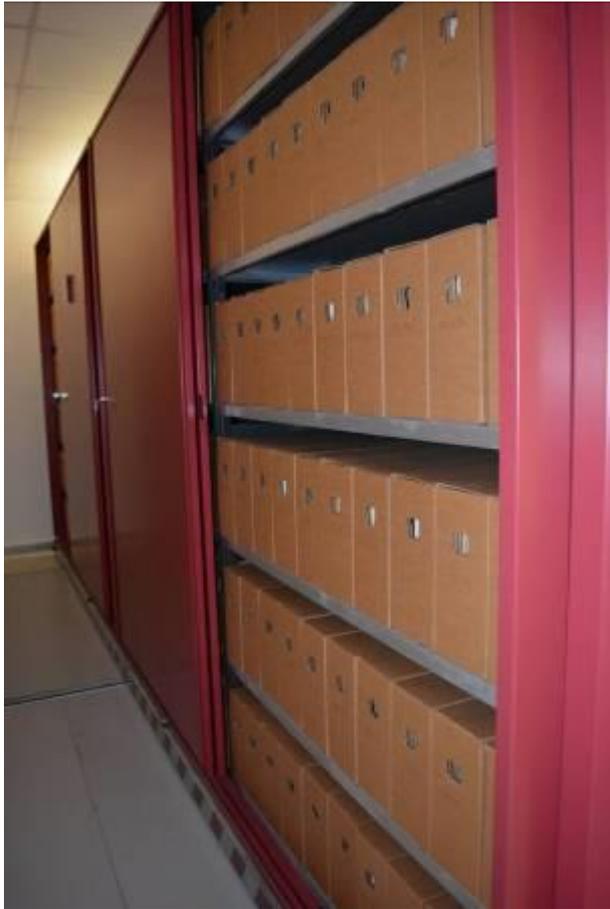
Given that all material is stored in stable environment, in appropriate mobile shelving units, elevated from the floor and distant from the walls, with a closed top and doors at the end units, the degree of exposure depends only on the storage enclosures (image 13). Oversized material, such as drawings, maps and parchments, as well as microfilms are kept separately in plan drawers and cabinets that provide higher protection of the material against the flood. Exposure to the environment is analyzed on the basis of the protection offered by 1) the special enclosure that keeps the vulnerability low, 2) the simple archival box that functions as a temporary wetting barrier and 3) plain storage with improper or without enclosure that makes the material the most vulnerable (image 14).

Image 13: End units with doors

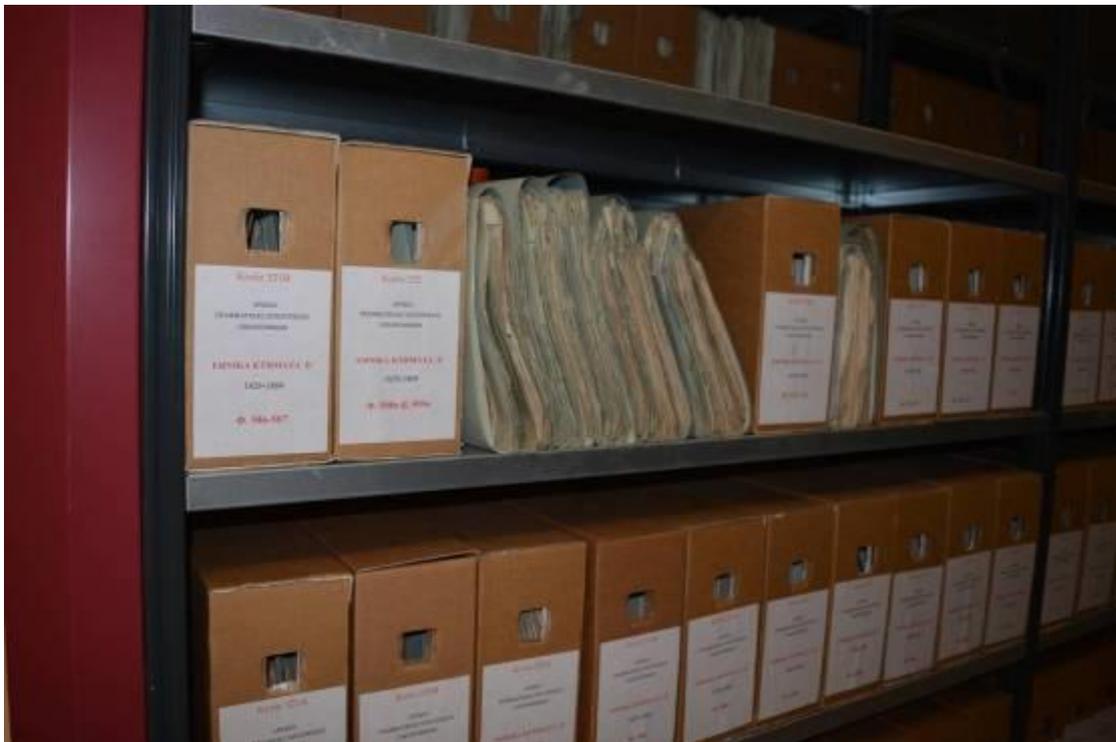
Image 14: Material with no enclosure next to material in archival boxes

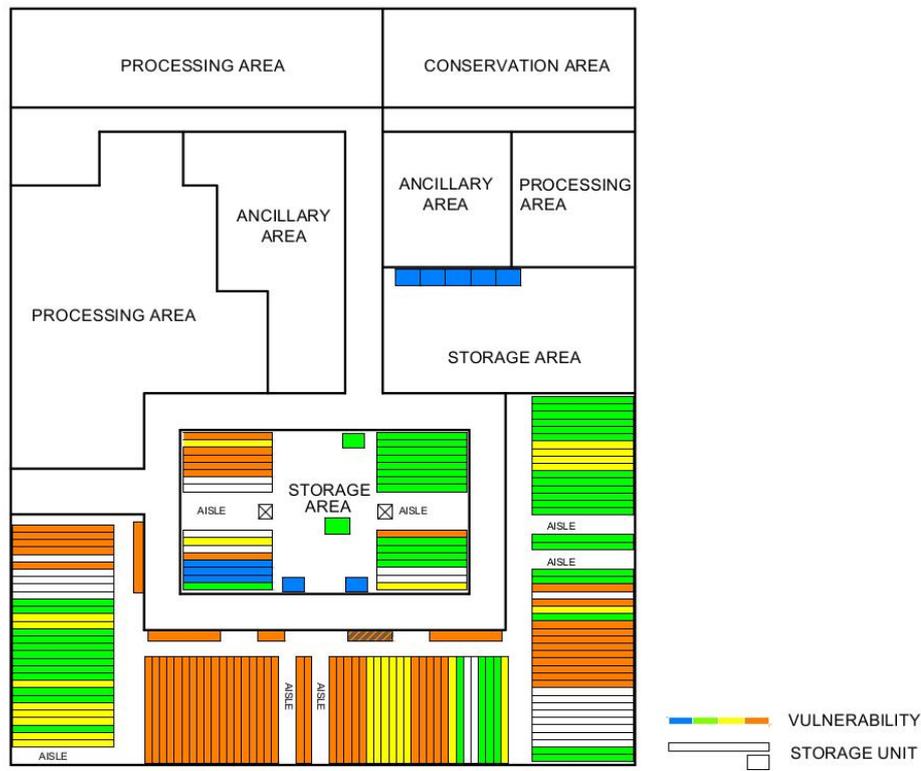
Collections constituted the assessment units since they cannot be separated intellectually and physically unless this is necessary for preservation purposes. The same applies when more than one collection are shelved in the same unit (image 15).

Image 15: Mapping of vulnerability

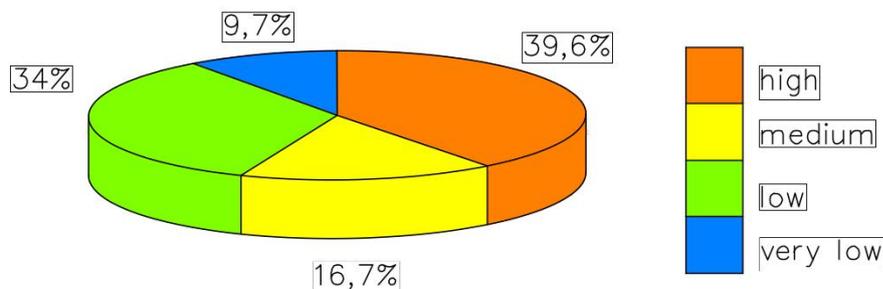
In the case of mixed collections, the percentage distribution of the types of material and protective enclosures was taken into account and an average vulnerability has been assigned. 43.7%, which represents nearly half of the material is characterized by low and 16.7% by medium vulnerability whereas 39.6% with higher vulnerability mainly concerns large size leather bound books of 19th century, placed directly on the shelf (image 16 & 17). But it is nonetheless of importance that the material of the highest sensitivity to water is found boxed and not exposed.

Image 16: Percentage distribution of vulnerability

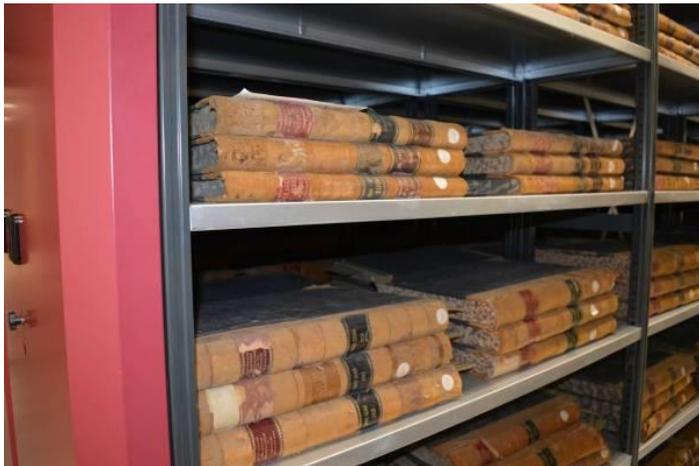
Image 17: Leather bound books with no enclosures

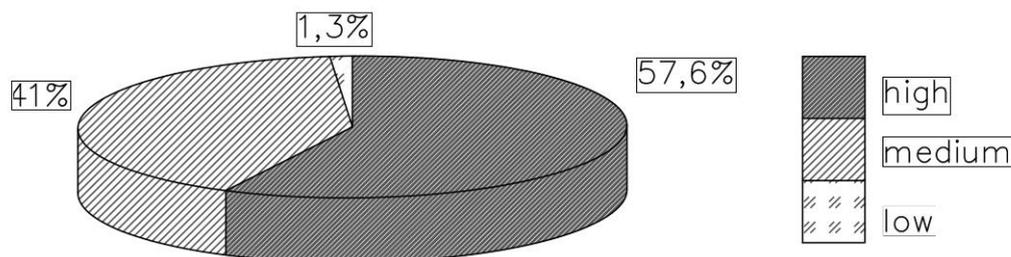
Results showed that, more than half of the archival collections (57.6%) was rated high, the rest almost (41%) medium, while a very small (1.3%) low (image 19). This is explained by the fact that the most important material of the Central Service is being stored in the area under study.

Image 19: Percentage distribution of collections value

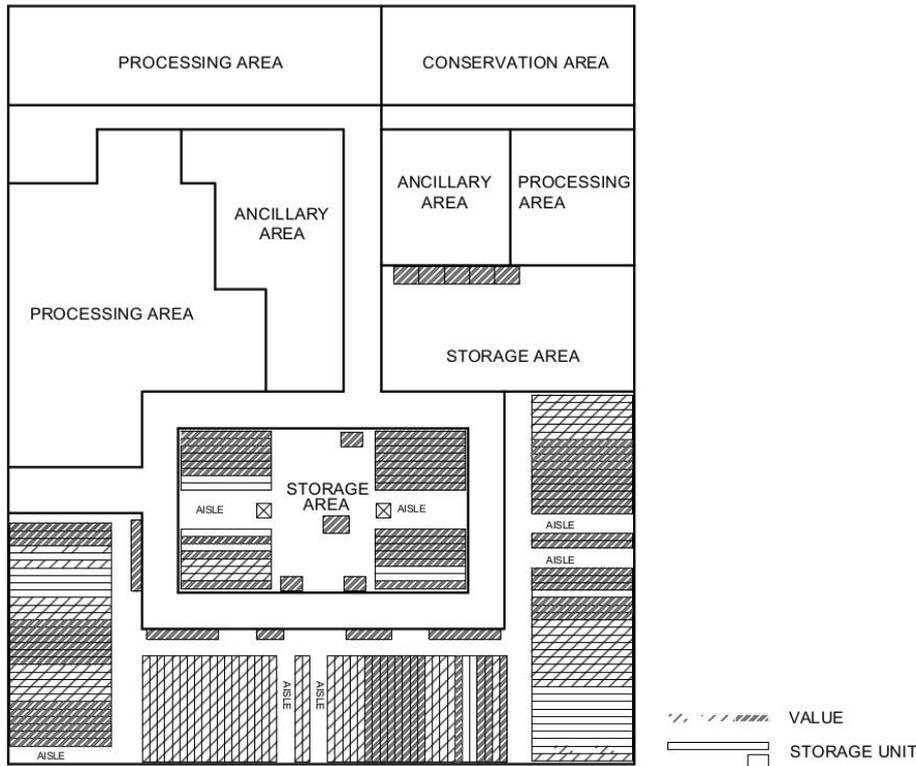
In the value map the representation unit is the storage unit (image 20). If this contains more than one collection, the total value assigned is the highest recorded even for one small collection. Value scores were represented with line patterns to differentiate from the color scale used for vulnerability (image 21).

Image 20: Mapping of collections value

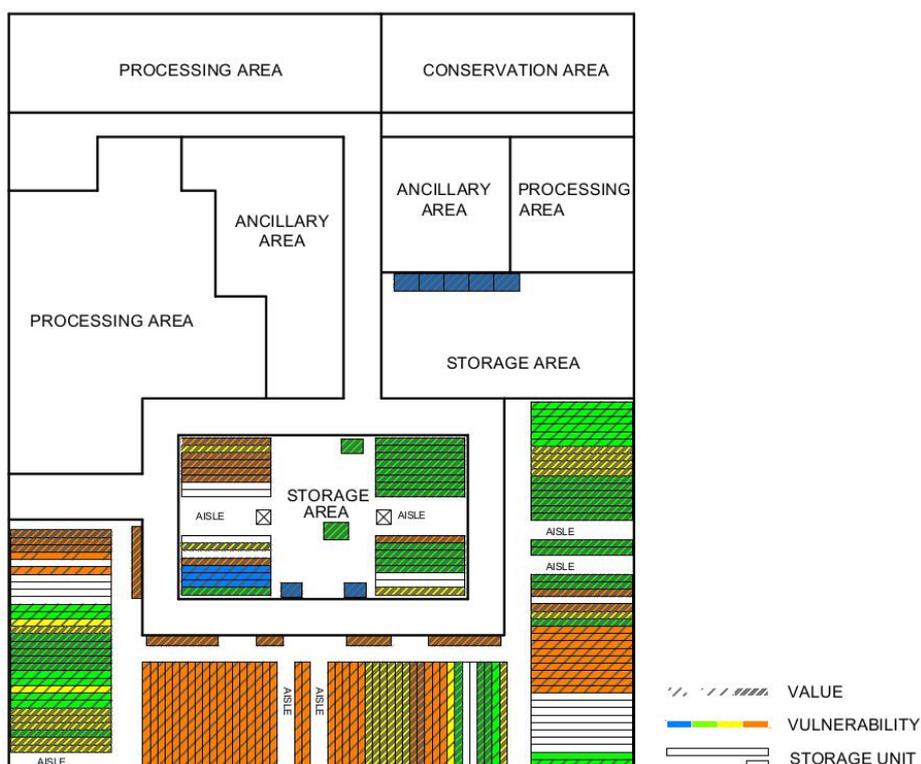
Image 21: Mapping of vulnerable value

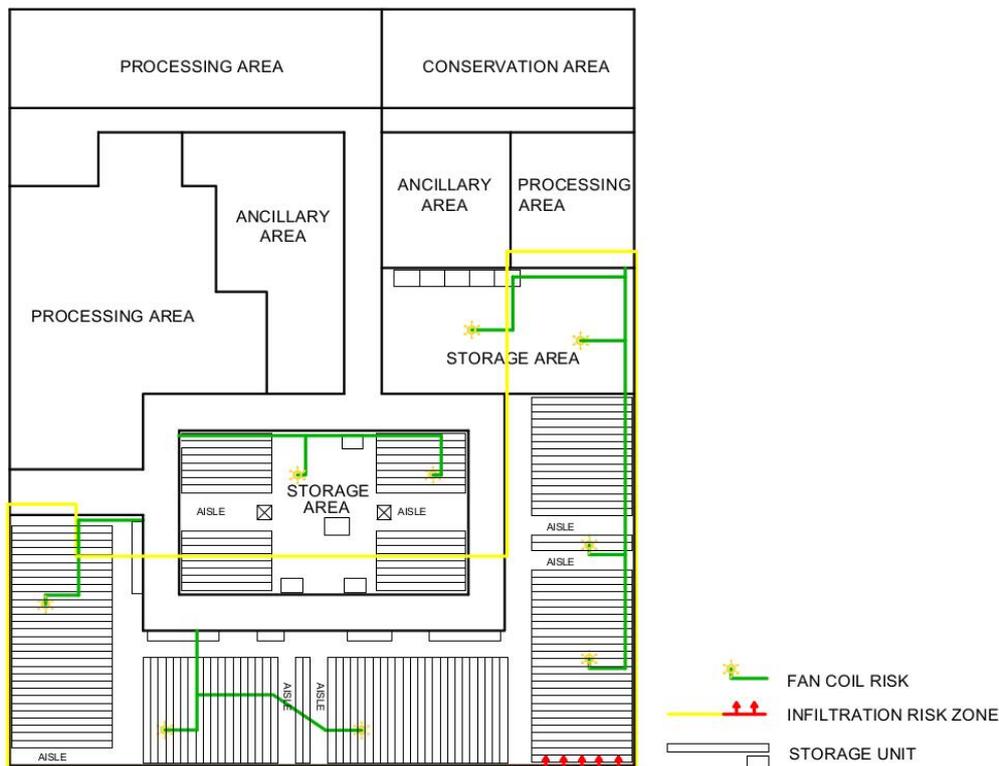
The question is how maps could help us to delimit the zones of potential flood risks. And how could they help to design targeted measures to mitigate loss. The maps, in fact, can indicate the wider only zones where different and difficult to predict risk scenarios can take place (image 22).

Image 22: Mapping of risk exposure in the storage rooms

space it would be rather out of place to discuss a major preventive reorganization of the collections on the shelves. However, it should be avoided that highly valued and vulnerable material is stored near the wall where water infiltration occurs.

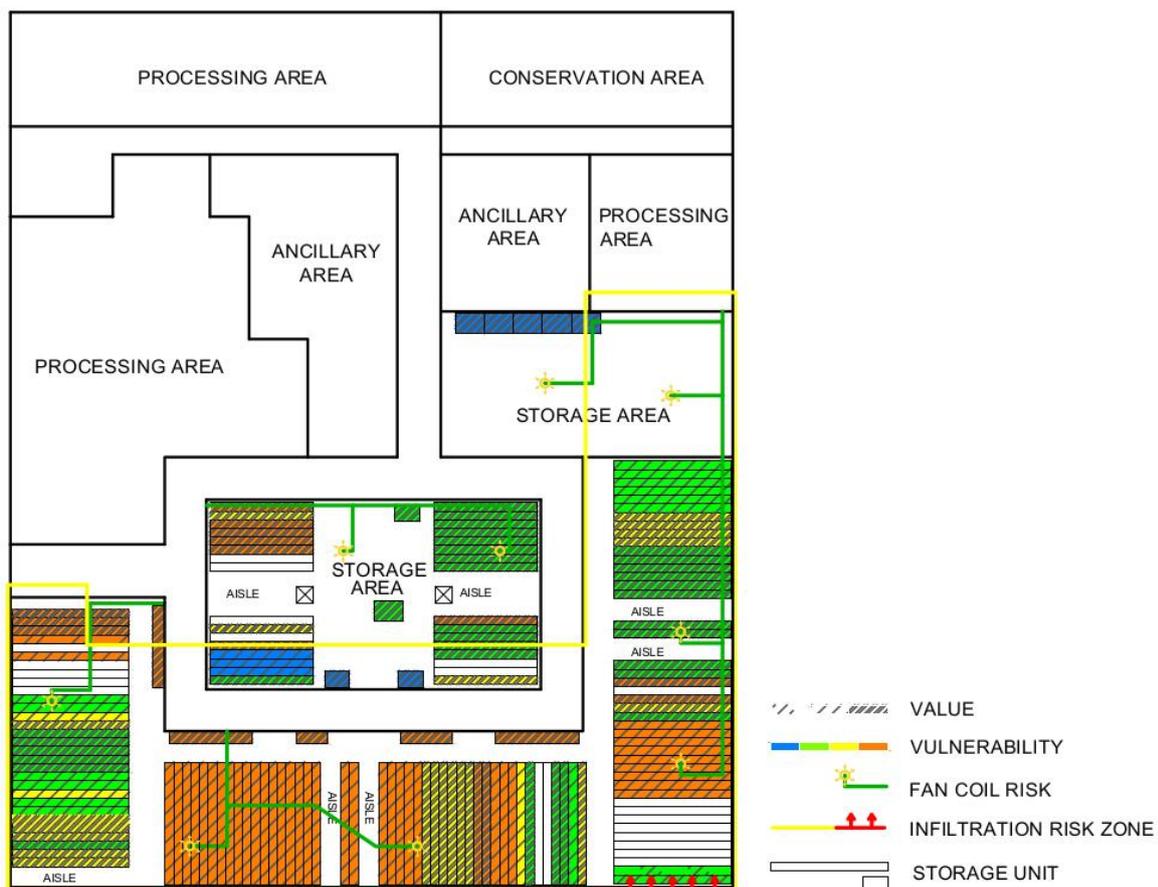
With separate and distinctive labeling of priorities we ensure that these collections are easily identified within the entire risk zone (image 23). Because compact mobile shelving doesn’t allow direct view and access to the material, it is necessary that this information is displayed on the front side of the unit, which is visible from the main aisle (image 24). In a second step, labeling along the shelves is the best practice to mark collections assessed differently between each other, allowing salvage in priority.

Image 23: Superimposing of the maps of risk exposure, collections value and vulnerability

In accordance with the risk management principle ‘we cannot save it all’, we should try to save first the most valuable and/or sensitive material away from the affected areas. In the case of medium vulnerable value priority should be given to value.

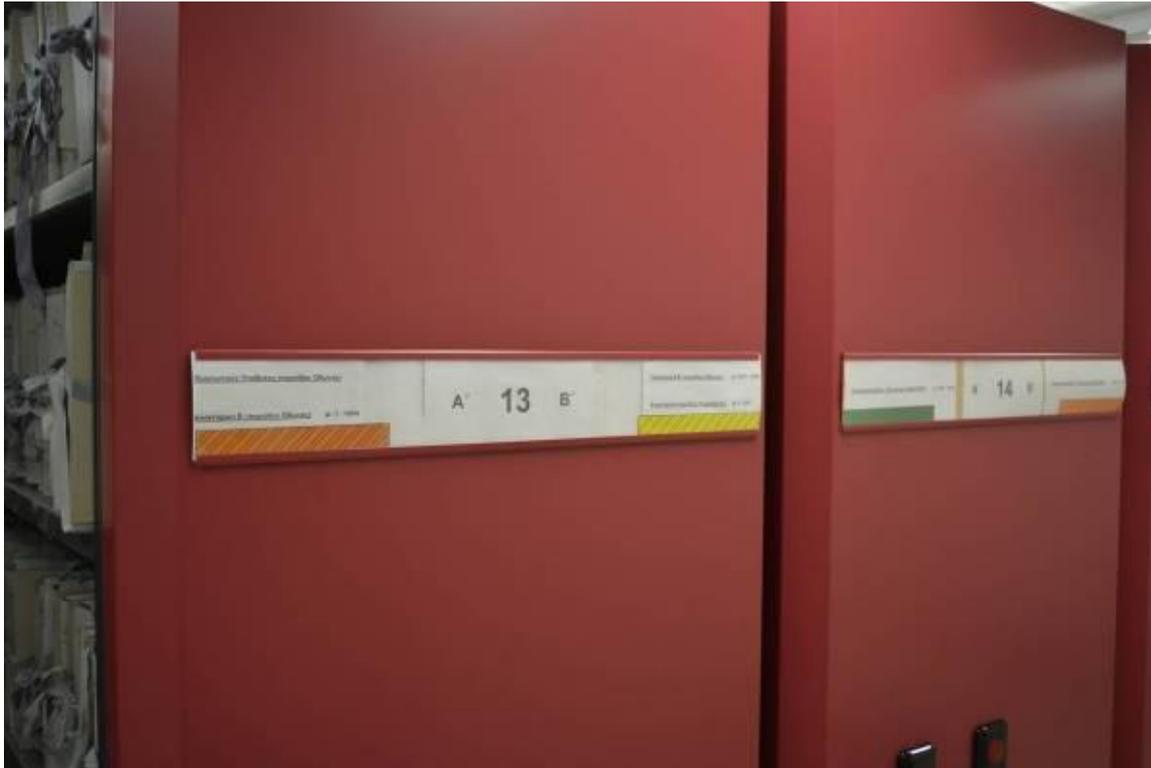
Image 24: Labeling of units with vulnerable value

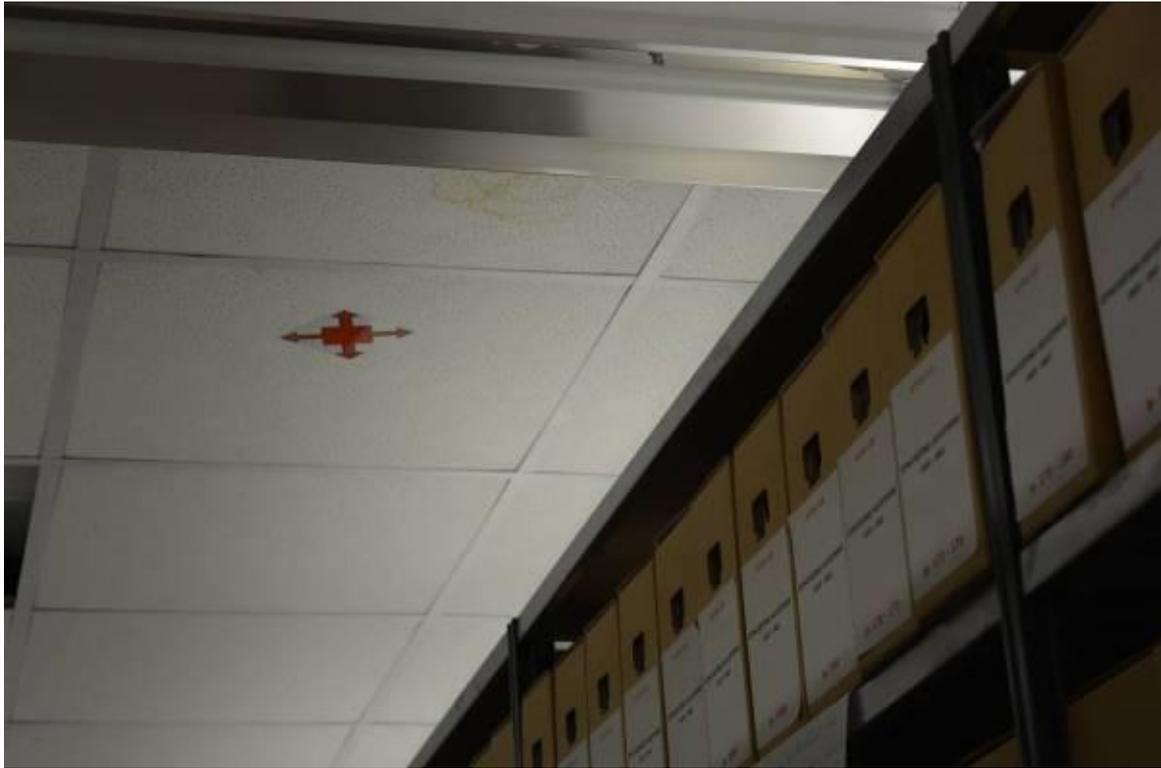
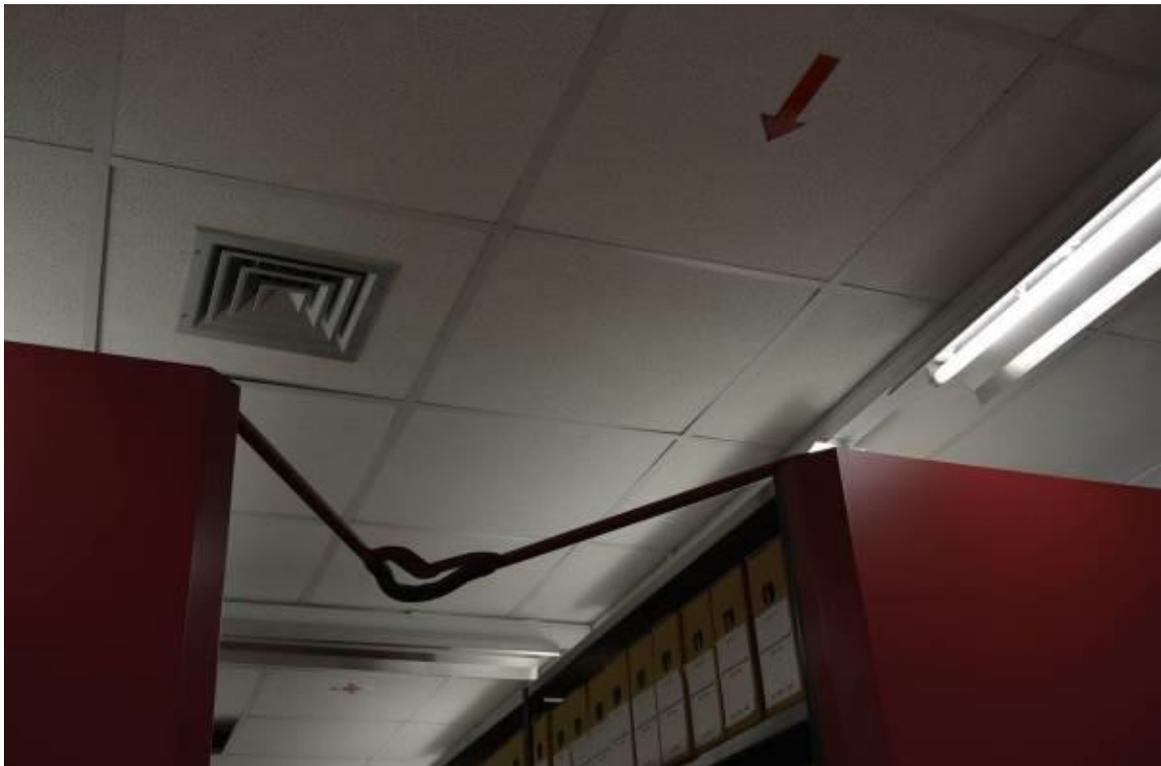
Image 25: Marking the fan coil unit locations on the ceiling

Image 26: Marking the fan coil unit locations on the ceiling

An alternative measure could be the scheduled monitoring of the ceiling by the personnel in charge of the material in the storage rooms. Marking of the fan coil unit locations on the ceiling is essential to facilitate inspections, since they are out of view (image 25). Mobile shelving offers the advantage to keep the aisle open where possible under the units, as a regular practice to avoid damage in an emergency (image 26). Well-trained employees can spot events ideally at the time they occur and take action so as they do not become problems for the archival material, thus minimizing if not eliminating risk.
