Relocation of Iconographic Collections as a disaster response to water activity in 17th century palace

Bogdan Filip Zerek

Institute for Conservation of Library Collections, National Library of Poland, Warsaw, Poland
b.zerek@bn.org.pl

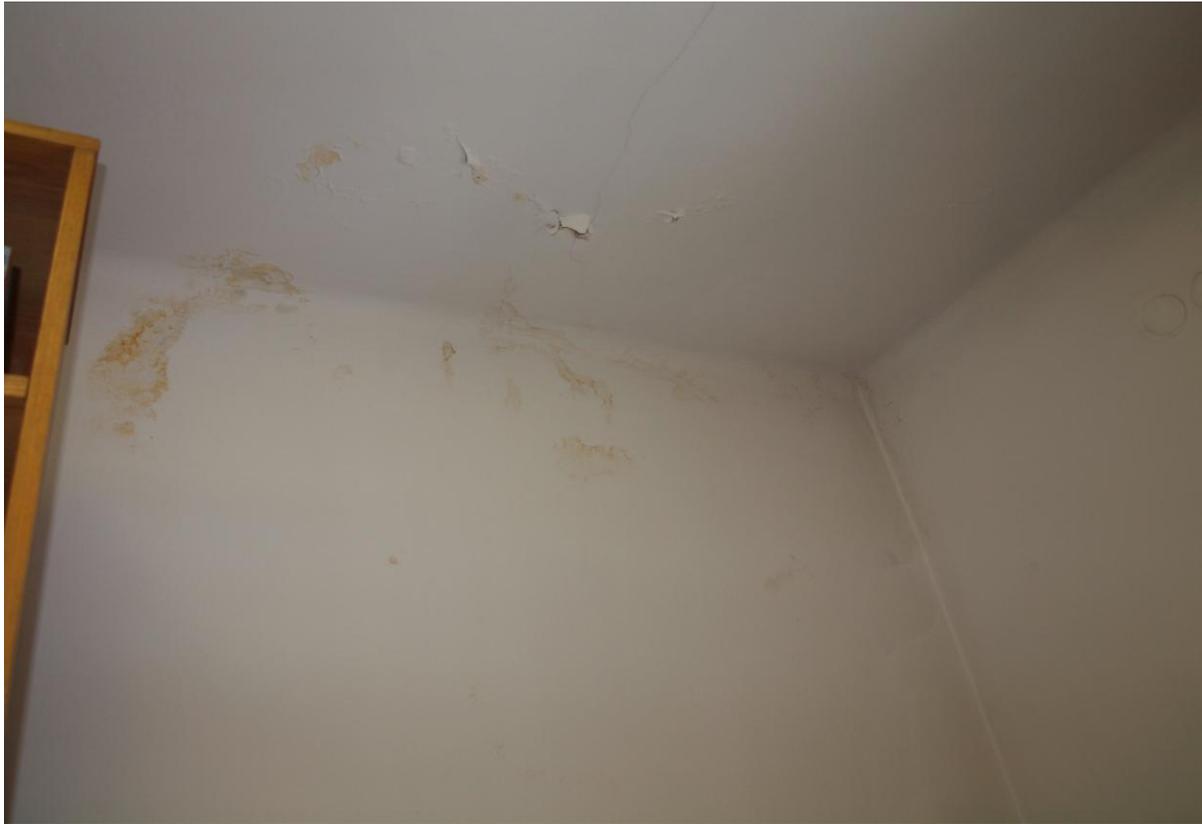
Figure 1. The bookcase in the storage room 218 is already removed and walls and ceiling does not look like heavily damaged. But any repair would require introducing the repair team and a lot of dust while removing the damaged layers of the wall probably down to the bricks.

The most probable reason of the water activity were leaks in the copper covering of the roof of Palace combined with excess of snow thawing upon it. It was controlled and repaired quickly, but the flooded walls and ceiling in storage rooms required repair. Because the room 218 is the last one in a row, it is accessible only through the storage rooms 214 (with reference collection) or 217 (with regular iconographic collections) and therefore no repairs could be executed without securing or removing collections of at least two rooms. In this particular case and considering the value of the collections as well as its vulnerability to dust (exceptionally photographic post-cards in the room 218) repairs in the rooms with objects of heritage was not an options. Since at least part of the collections had to be removed we came to idea of relocating all of them to the main building with full climate control (air-conditioning). This solution brought some extra advantages for the objects: new furniture (steel one instead of old wooden one), possibility of immediate conservation actions (without transportation of objects between the Palace and the main building), better access for the readers.

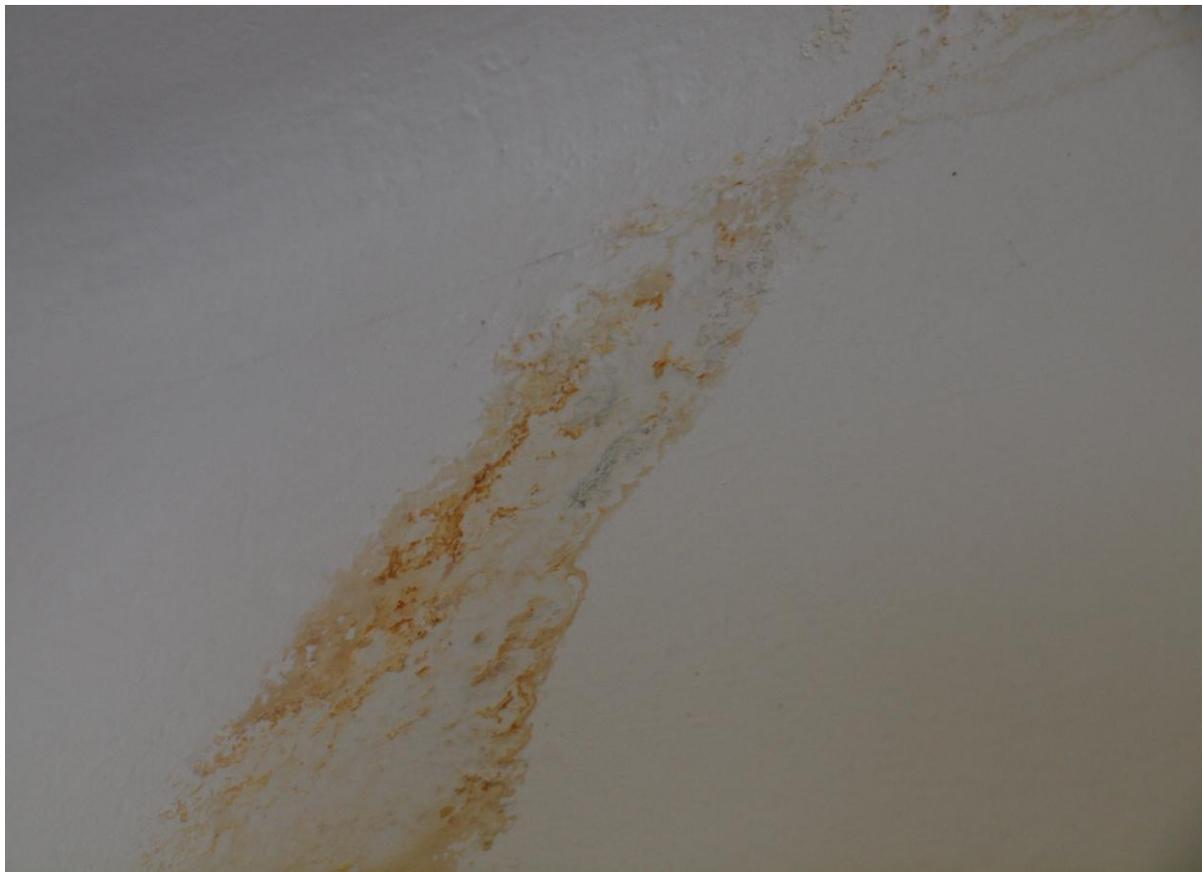
Figure 2. After few days greenish shades appeared. It is an evidence of mould growth, probably of

Penicillium genus. Immediate counter-action stopped the growth, but the key is to eliminate the cause (humidity of the wall), not only the symptom.

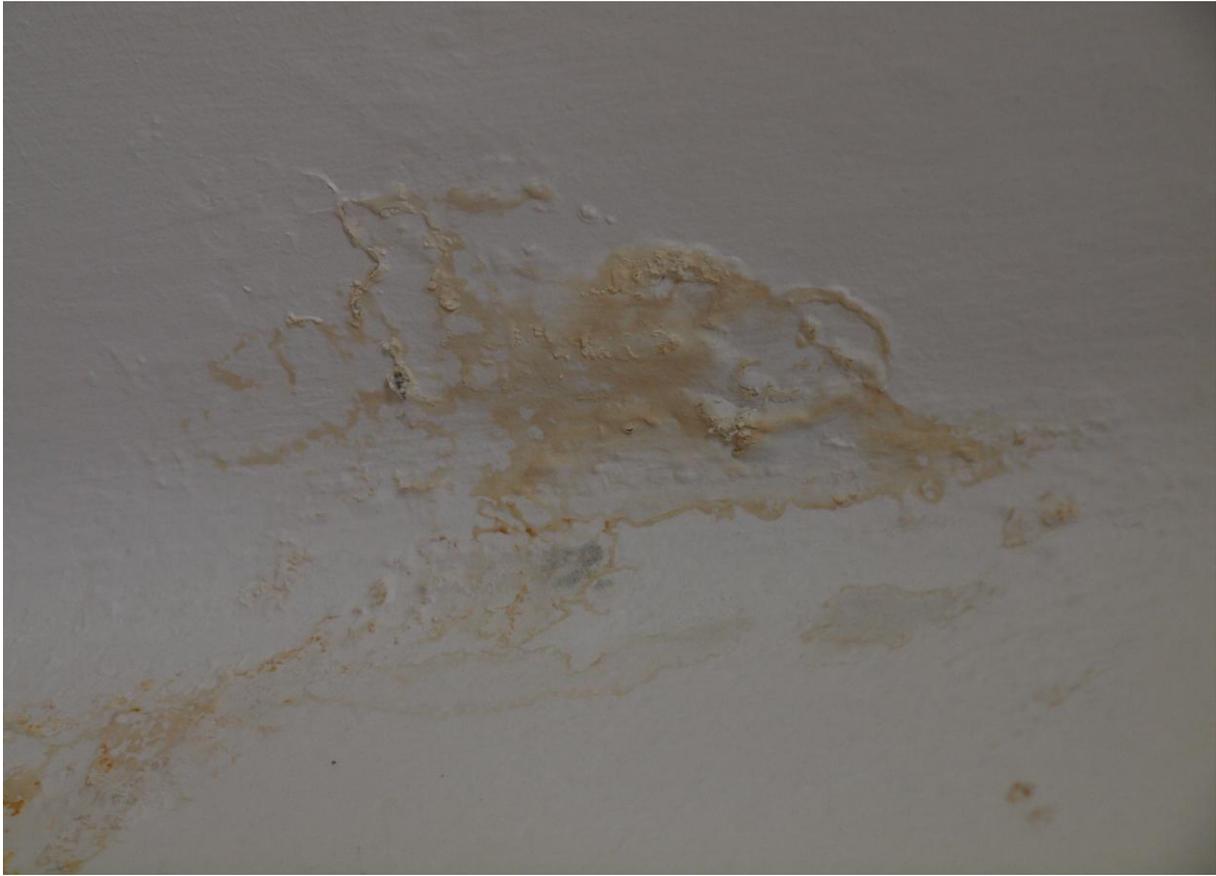
Figure 3. Another example of damage: the plaster layer is peeling off in blisters and flakes, emitting dirt and probably CFUs (again the green shades). The wall and ceiling should be explored till firm layers undamaged by water. Difficult to perform with collections remaining in the room; this problem however was solved couple of years later.

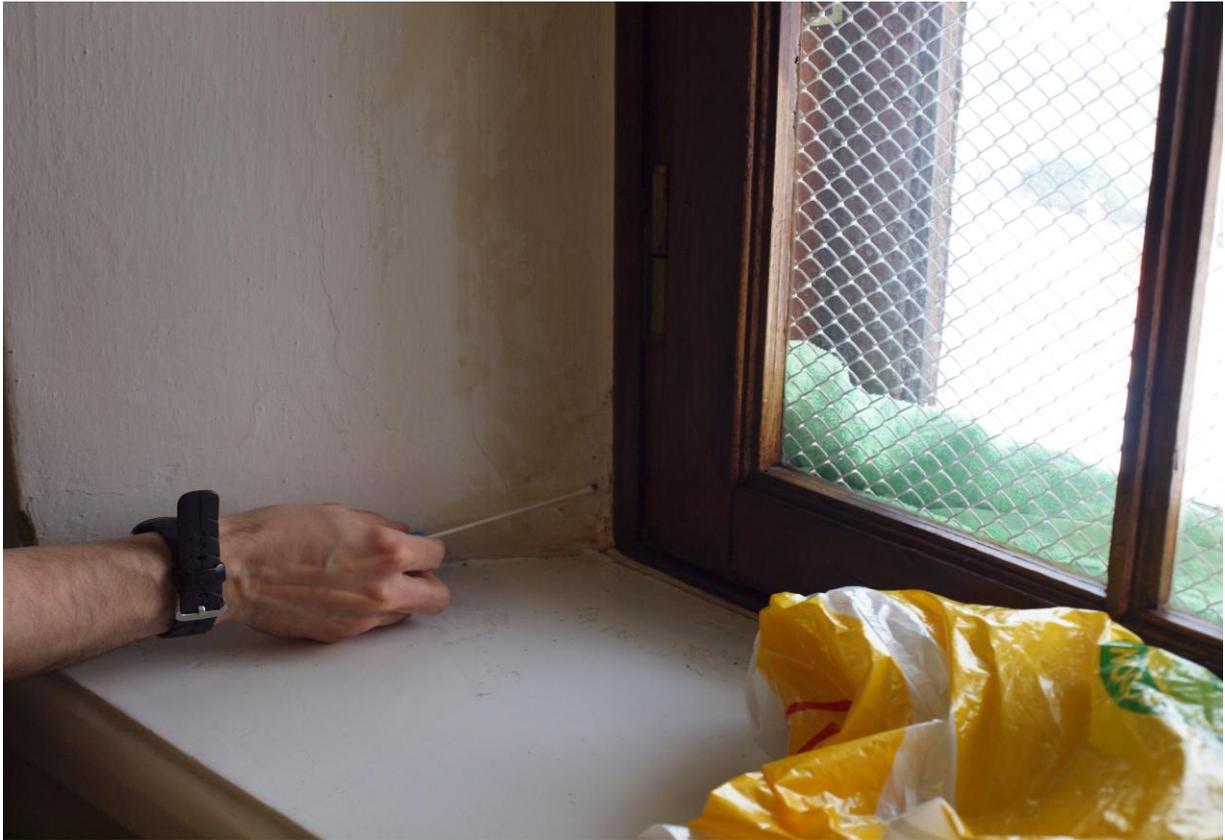
Figure 4. Collecting a dry swab from the window area. Note the evidence of humidity by the window frame and the *ad hoc* counter action - towel between outer and inner window. Today we have already new windows.

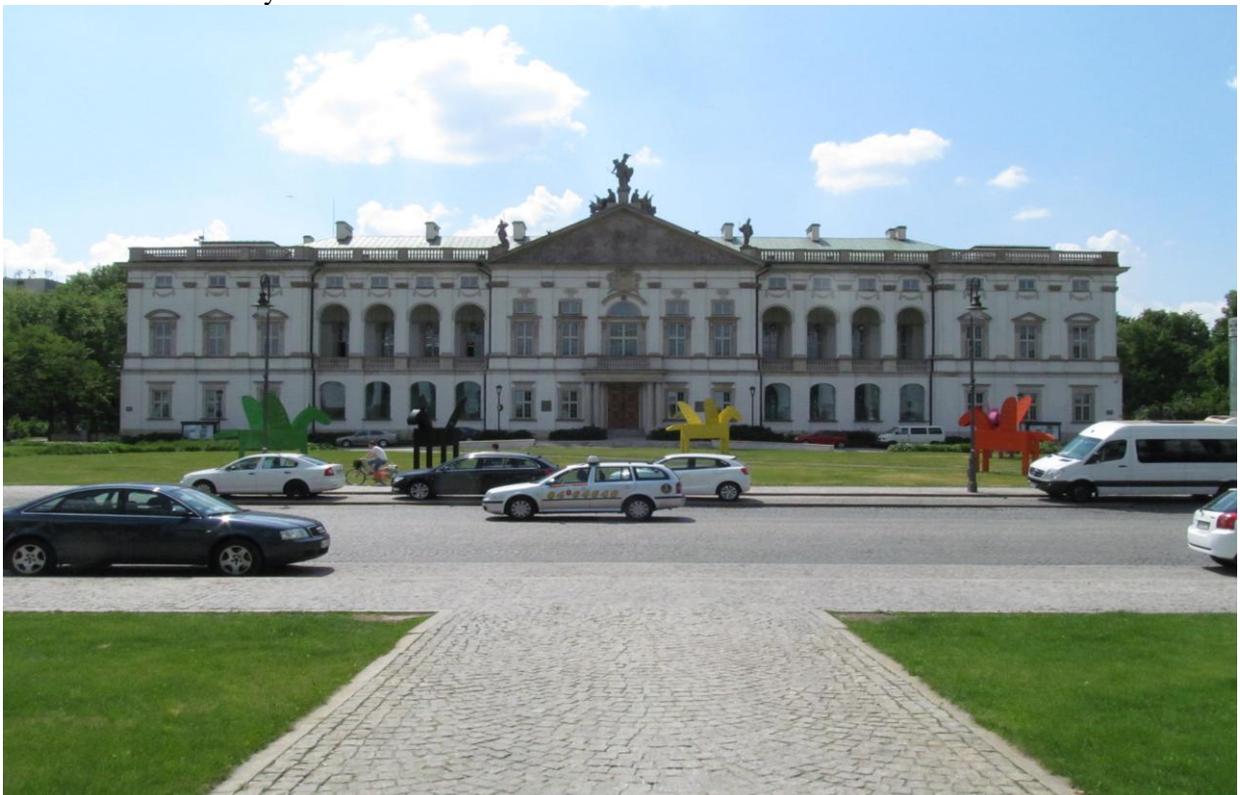
Figure 5. View of the Palace from the Krasinski Square. The two right windows above the second level of arcades just left to the tympanum are the windows of the storage room 218. The water activity appeared on the wall that separates room 218 from the Wilanowska Hall (five

windows below the tympanum) also containing early prints.
